FACULTAD DE ESTUDIOS SUPERIORES CUAUTITLÁN

LABORATORIO DE TECNOLOGÍA DE MATERIALES

LECTURAS DE INGENIERÍA 18

FATIGUE, AN OVERVIEW

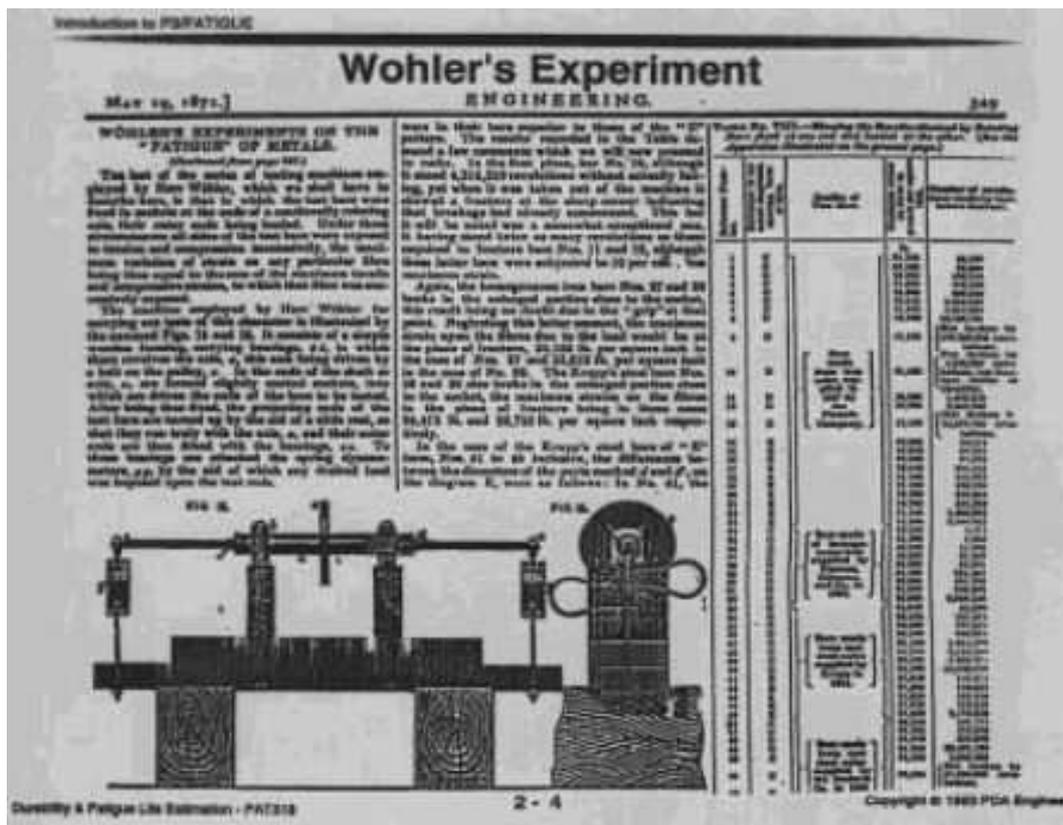
Figure 1.2. Publication of Wöhler's fatigue experience, 1871

His work on fatigue marks the first systematic investigation of σ - N Curves, also known as *Wöhler curves*, to characterise the fatigue behaviour of materials. Such curves can be used to minimise the problem of fatigue by lowering the stress at critical points in a component. Wohler showed clearly that fatigue occurs by crack growth from surface defects until the product can no longer support the applied load. The history of a fracture can be understood from a study of the fracture surface. He developed apparatus for repeated loading of railway axles, mainly because many accidents were caused by sudden fatigue fracture. The presentation of his work at the Paris Exposition in 1867 brought it to a wide international audience.

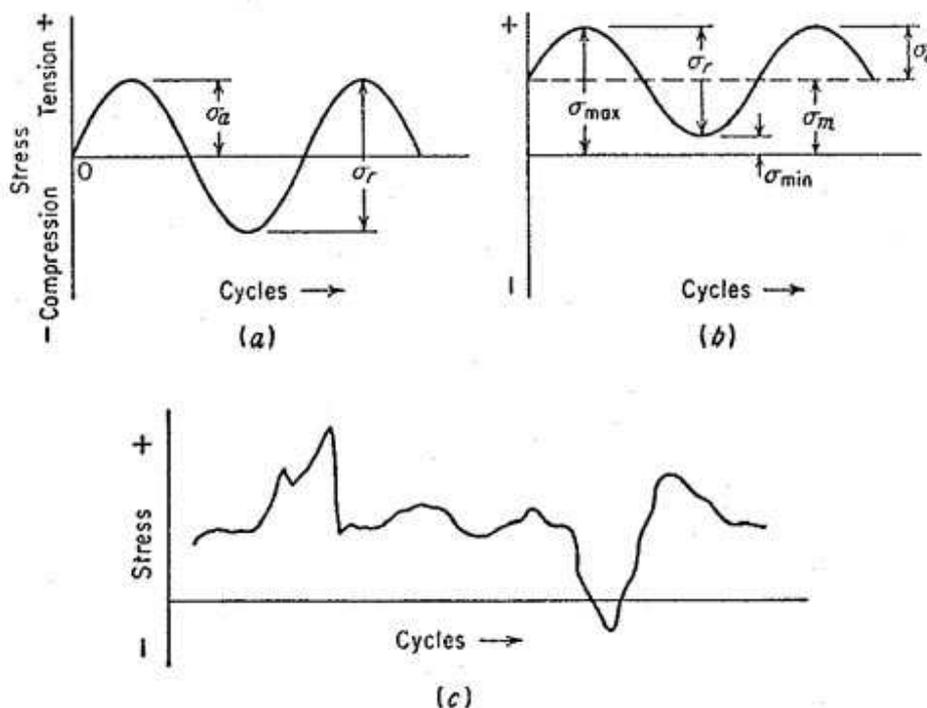
Figure 1.3. Typical fatigue stress cycles. (a) Reversed stress; (b) repeated stress; (c) irregular or random stress cycle.

At the outset it will be advantageous to define briefly the general types of fluctuating stresses which can cause fatigue. Figure 1 serves to illustrate typical fatigue stress cycles.

Figure 1a illustrates a completely reversed cycle of stress of sinusoidal form. For this type of

stress cycle the maximum and minimum stresses are equal. Tensile stress is considered positive, and compressive stress is negative.

Figure 1b illustrates a repeated stress cycle in which the maximum stress σ_{\max} (R_{\max}) and minimum stress σ_{\min} (R_{\min}) are not equal. In this illustration they are both tension, but a repeated stress cycle could just as well contain maximum and minimum stresses of opposite signs or both in compression.

Figure 1c illustrates a complicated stress cycle which might be encountered in a part such as an aircraft wing which is subjected to periodic unpredictable overloads due to gusts.

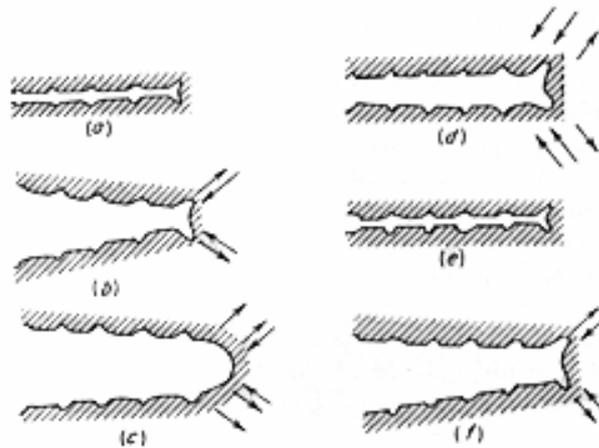
Figure 1.4. Plastic blunting process for growth of stage II fatigue crack

Stage II crack propagation occurs by a plastic blunting process that is illustrated in Fig. 1.

At the start of the loading cycle the crack tip is sharp (Fig. 1 a). As the tensile load is applied the small double notch at the crack tip concentrates the slip along planes at 45° to the plane of the crack (Fig. 1b). As the crack widens to its maximum extension (Fig. 1c) it grows longer by plastic shearing and at the same time its tip becomes blunter. When the load is changed to compression the slip direction in the end zones is reversed. The crack faces are crushed together and the new crack surface created in tension is forced into the plane of the crack (Fig. 1e).

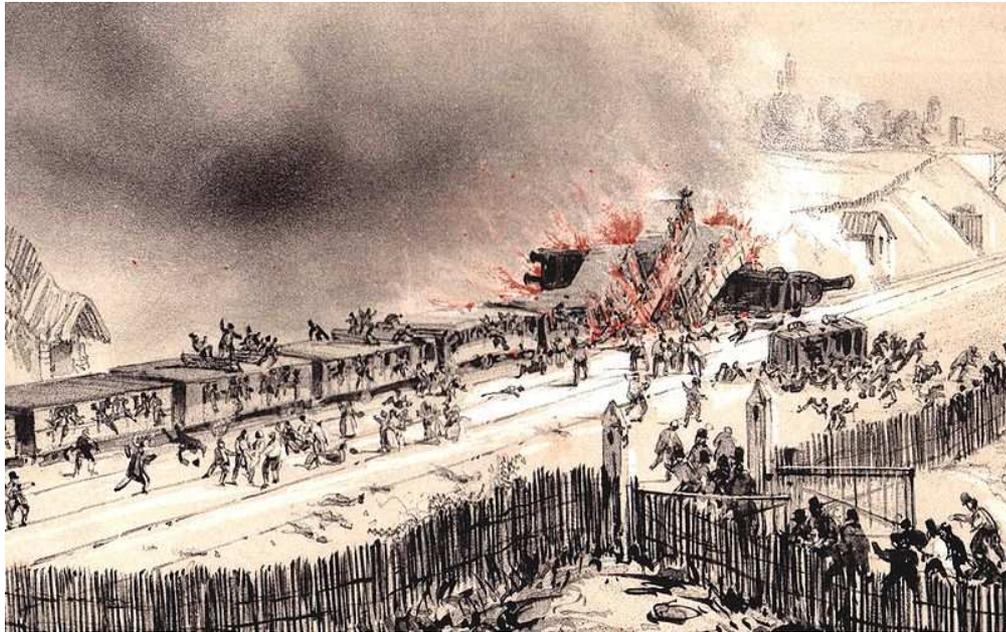
Figure 1.5. Versailles train crash in 1842

The derailment had been the result of a broken locomotive axle. Rankine's investigation of broken axles in Britain highlighted the importance of stress concentration, and the mechanism of crack growth with repeated loading. His and other papers suggesting a crack growth mechanism through repeated stressing, however, were ignored, and fatigue failures occurred at an ever increasing rate on the expanding railway system. Other spurious theories seemed to be more acceptable, such as the idea that the metal had somehow "crystallized". The notion was based on the crystalline appearance of the fast fracture region of the crack surface, but ignored the fact that the metal was already highly crystalline.

Following the King's fete celebrations at the Palace of Versailles, a train returning to Paris crashed in May 1842 at Meudon after the leading locomotive broke an axle. The carriages behind piled into the wrecked engines and caught fire. At least 55 passengers were killed trapped in the carriages, including the explorer Jules Dumont d'Urville. This accident is known in France as the "Catastrophe ferroviaire de Meudon". The accident was witnessed by the British locomotive

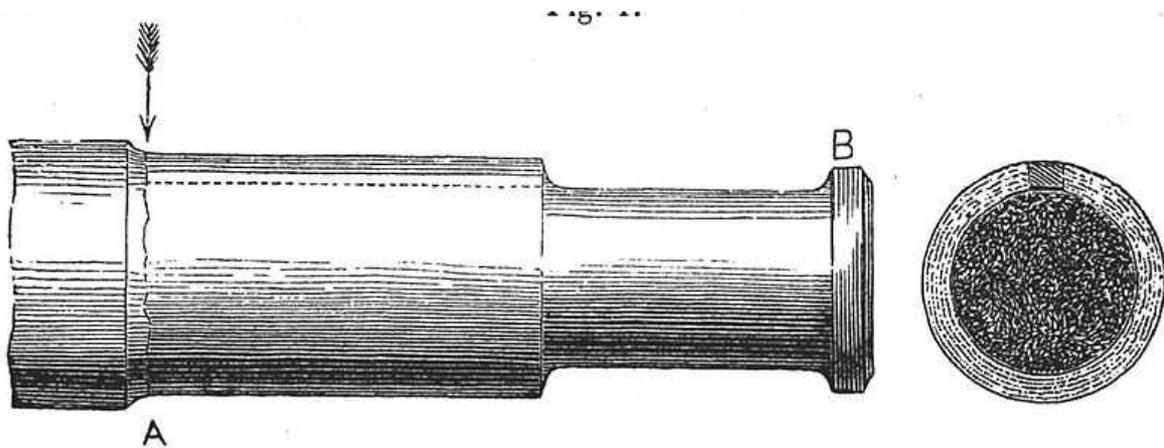
Figure 1.6. Drawing of a fatigue failure in an axle by Joseph Glynn, 1843

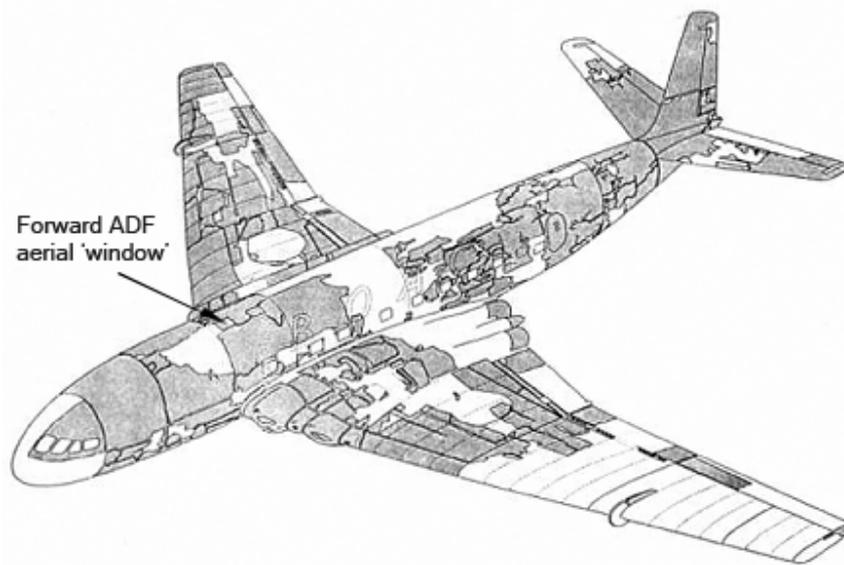
Figure 1.7. Comet 1 G-ALYP - wreckage recovered

Two de Havilland Comet passenger jets broke up in mid-air and crashed within a few months of each other in 1954. As a result systematic tests were conducted on a fuselage immersed and pressurised in a water tank. After the equivalent of 3,000 flights investigators at the Royal Aircraft Establishment (RAE) were able to conclude that the crash had been due to failure of the pressure cabin at the forward Automatic Direction Finder window in the roof. This 'window' was in fact one of two apertures for the aerials of an electronic navigation system in which opaque fibreglass panels took the place of the window 'glass'. The failure was a result of metal fatigue caused by the repeated pressurisation and de-pressurisation of the aircraft cabin. Another fact was that the supports around the windows were riveted, not bonded, as the original specifications for the aircraft had called for. The problem was exacerbated by the punch rivet construction technique employed. Unlike drill riveting, the imperfect nature of the hole created by punch riveting caused manufacturing defect cracks which may have caused the start of fatigue cracks around the rivet.

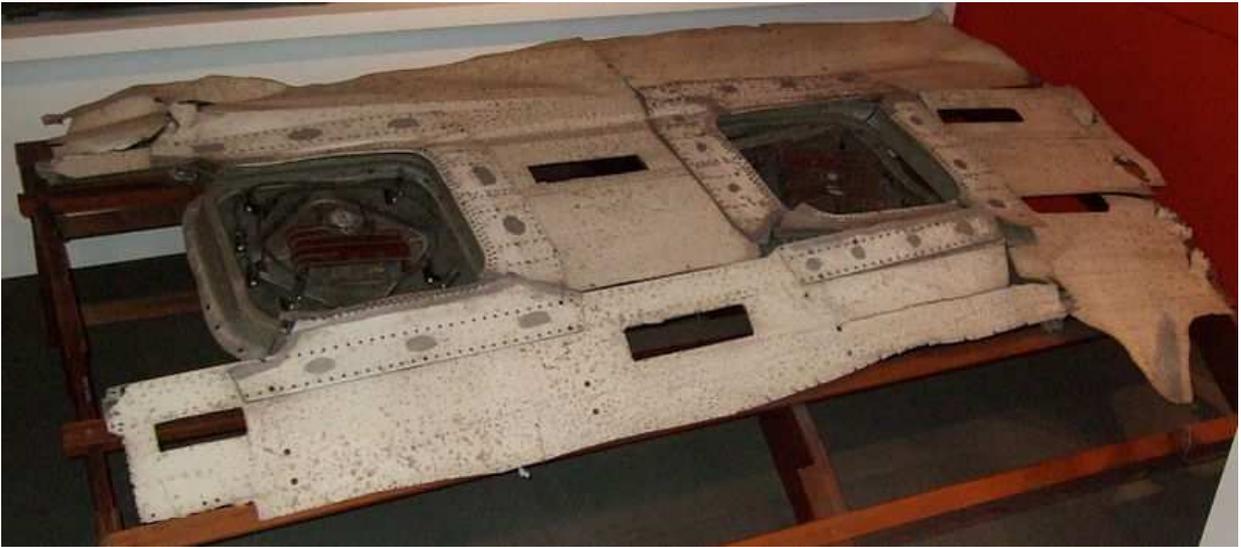
Figure 1.7. The fuselage fragment of G-ALYP on display in the Science Museum in London

The Comet's pressure cabin had been designed to a safety factor comfortably in excess of that required by British Civil Airworthiness Requirements (2.5 times the cabin proof pressure as opposed to the requirement of 1.33 times and an ultimate load of 2.0 times the cabin pressure) and the accident caused a revision in the estimates of the safe loading strength requirements of airliner pressure cabins.

In addition, it was discovered that the stresses around pressure cabin apertures were considerably higher than had been anticipated, especially around sharp-cornered cut-outs, such as windows. As a result, all future jet airliners would feature windows with rounded corners, the curve eliminating a stress concentration. This was a noticeable distinguishing feature of all later models of the Comet. Investigators from the RAE told a public inquiry that the sharp corners near the Comets' window openings acted as initiation sites for cracks. The skin of the aircraft was also too thin, and cracks from manufacturing stresses were present at the corners.

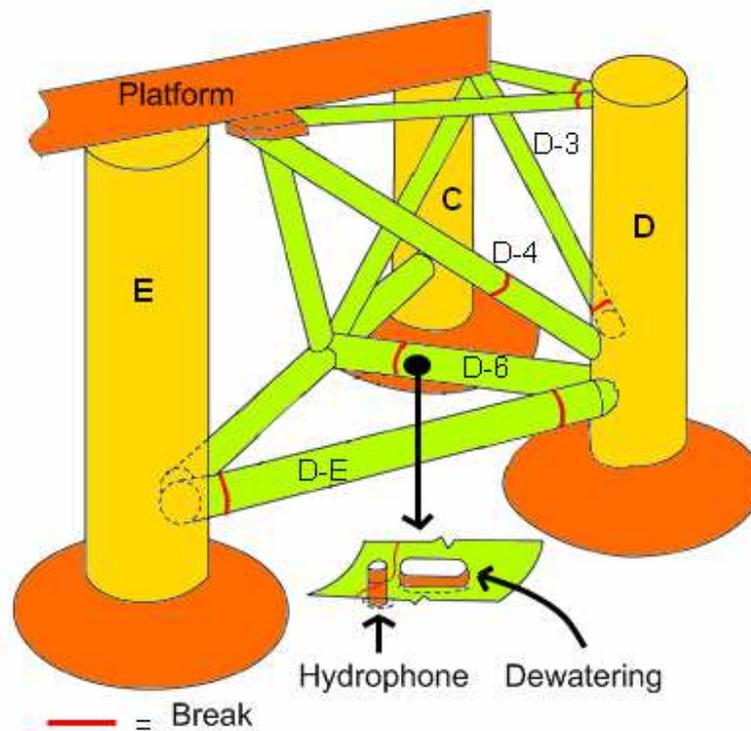
Figure 1.8. ALK columns fractures

A year later in March 1981, the investigative report concluded that the rig collapsed owing to a fatigue crack in one of its six bracings (bracing D-6), which connected the collapsed D-leg to the rest of the rig. This was traced to a small 6 mm fillet weld which joined a non-load-bearing flange plate to this D-6 bracing. This flange plate held a sonar device used during drilling operations. The poor profile of the fillet weld contributed to a reduction in its fatigue strength. Further, the investigation found considerable amounts of lamellar tearing in the flange plate and cold cracks in the butt weld. Cold cracks in the welds, increased stress concentrations due to the weakened flange plate, the poor weld profile, and cyclical stresses (which would be common in the North Sea), seemed to collectively play a role in the rig's collapse.

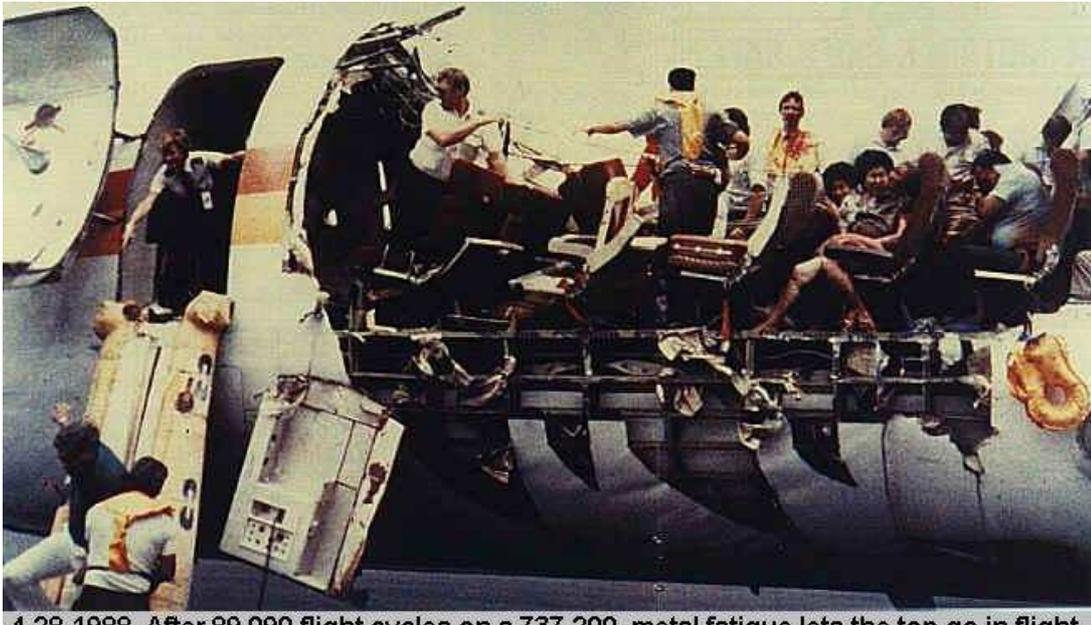
Figura 1.9. After 89,090 flight cycles on a 737-200, metal fatigue lets the top go in flight (28-abril-1988)

It was later determined that the failure was caused by widespread fatigue damage in the aluminum skin of the fuselage. It was calculated that this particular aircraft had experienced 89,090 flight cycles over its 19 year life span. What caused this failure, and how could it have been prevented?

The investigation into the failure of Aloha Flight 243 concluded that the widespread fatigue damage that led to the ultimate failure was caused by the aircraft's exceptionally large number of flight cycles and accelerated by the exposure of the aircraft to corrosive salt water vapor during its inter-island flights. The combination of these two factors led to the creation of small crack throughout the fuselage lap joints that eventually linked to form larger cracks and eventually fail completely

The fuselage cracks originated in the lap joints of the aircraft skin. These horizontal seams connect the aluminum sheets that make up the skin of the aircraft. The two sheets are overlapped
